GEO-Instruments monitors changes in parameters that affect the performance of a structure: tilt, settlement, load and strain, vibration, cracks and joints, and alignment of incoming utilities.

One Post Office Square

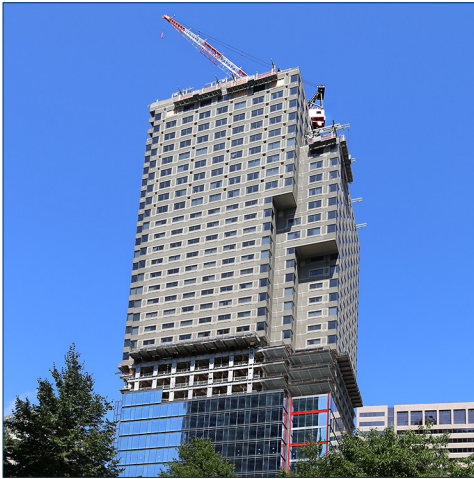
This 42-story skyscraper in Boston underwent extensive renovations to improve both its appearance and its energy efficiency. The structure's original cladding was replaced by a glass curtain. The photo above shows a small portion of the glass curtain. The project also replaced the original 6-story parking garage with an 18-story parking and office structure.

GEO installed six pairs of arc-weldable strain gauges on selected structural elements. Self-powered, wireless nodes transmitted measurements to an internet gateway.

Eight hydrostatic level cells were installed in the basement along with 8 wireless tiltmeters to monitor vertical columns during demolition of the adjacent parking garage.

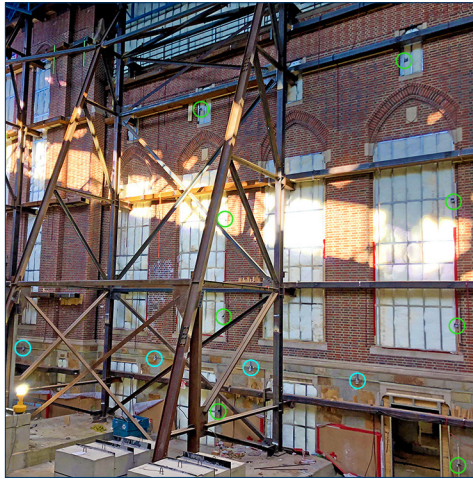
GEO installed wireless tiltbeam sensors in window openings to monitor for deformation and changes in tilt. In the photo above, eight of the tiltbeam sensors are circled in green.

GEO installed hydrostatic level cells along the base of the wall to monitor potential settlement. These were interconnected with electrical cable and liquid-filled tubing. Four of the cells are circled in blue in the photo above.

The Wellesley College Science Center upgrade project involved replacing the interior of the structure while preserving the original brick facade.

Wireless crackmeters monitored movement of the wall relative to an elevator shaft, and two automated vibration monitored vibration levels in a utility tunnel at basement level.
